Development and assessment of models for the durability and preventive conservation of historic plasterwork from the decorative elements of the Real Alcázar of Seville

Summary

PGC2018-100680-B-C21

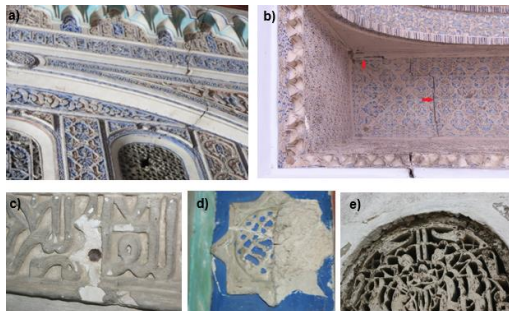
Figure 1. Examples of anomalies in the plasterworks of the Real Alcázar: a) Hall of the Ambassadors, with severe cracking and detachment of material; b) crack detection in plasterworks at Patio de las Doncellas; c) damage caused by rusted metal fixing; d) detachment; e) wear by water action.

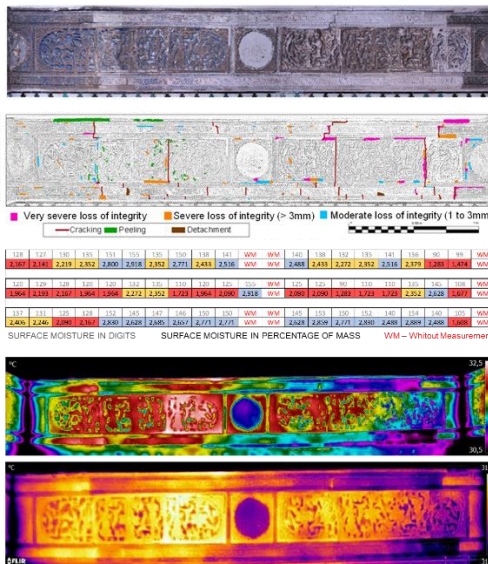
Figure 2. Assessment of the anomalies in a plasterwork of Patio de las Doncellas: mapping of the anomalies; humidity measurements made in situ; thermographic images.
